Addendum #1

Project: BL143C Social Research-Rehabilitate Exterior Envelope, Windows, Roof
Project Number: 20230523
Date: March 12, 2025

**Indiana University – Environmental Health and Safety
Asbestos Inspection Report
November 25, 2019**

Building: BL 143C – Social Research

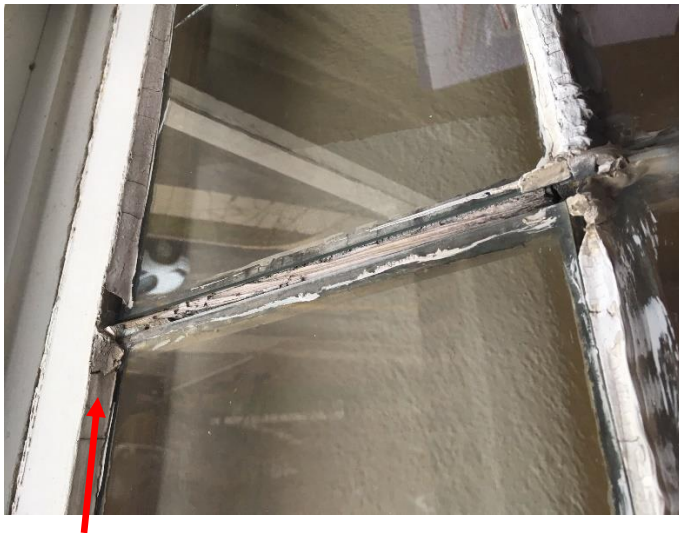
Window Glazing

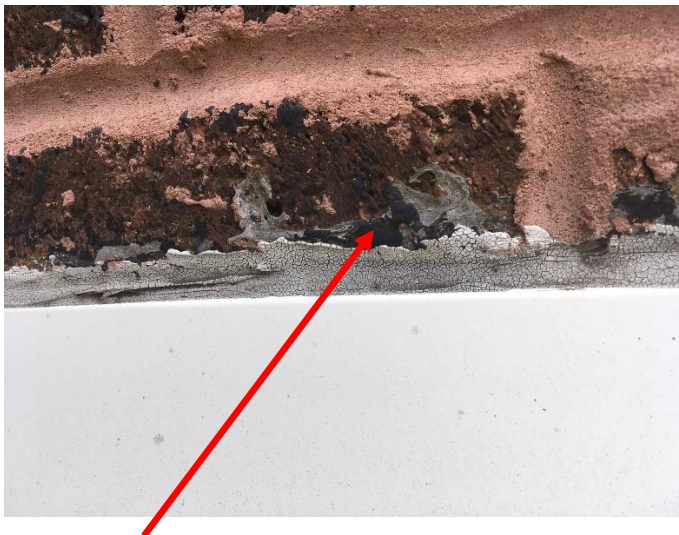
Black tar flashing/sealant

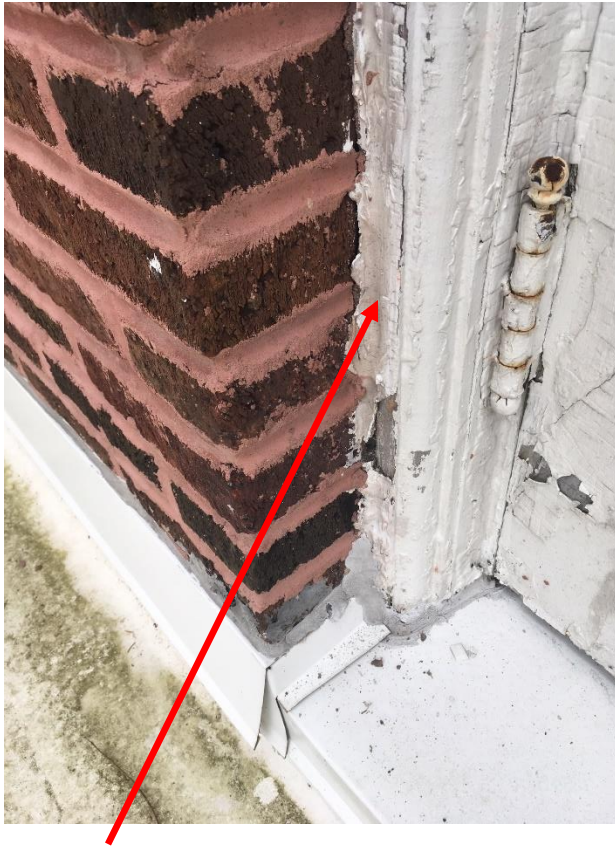
Window Caulking
